**SAS Superstructure**

Location: 04-SF-80-13.2 / 13.9

Daily Diary Report by Bid Item

Diary #: 475 Const Calendar Day: 239 Date: 29-Jan-2013 Tuesday

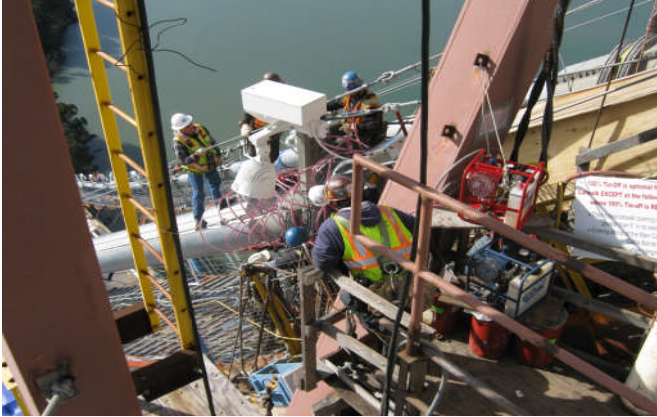
All of the new bolts manifolded together for final tensioning

- The shims previously installed near bolt numbers 2, 4, & 6 were removed & the butyl rubber was installed in the CB gap.
- New CB bolt number 2, 4, 6, & 8 were tensioned at 29,000 psi (about 1.4 MN).
- All of the new bolts were tensioned simultaneously to 29,000 psi (about 1.4 MN). The pressure was cycled up 3 times to try to minimize seating losses. See attached photo.
- Extensometer measurements were jointed taken by both ABF & Caltrans. B. Jones & A. Reeve did the measuring for ABF, & M. Bruce, J. Lyons, & L. Woo did the measuring for Caltrans. I calculated the new elongations & load on each of the new bolts. The minimum load on the new bolts was about 1.05 MN, & the average was about 1.2 MN. 3 of the bolts (numbers 1, 3, & 5) showed high loads. They were each around 1.5 MN. This information was given to Roman Granados, Warren Collins, & Tai-Lin Liu for analysis.

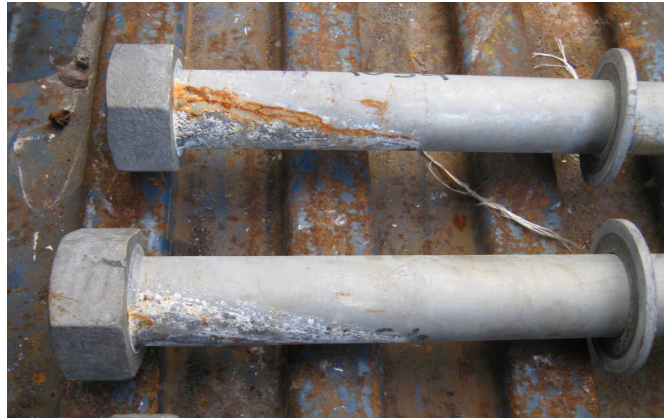
- Note: there was some rust noted on the CB bolts near the head of the bolts. See attached photo.
- New CB bolt numbers 2, 4, 6, & 8 were installed.
- 6mm thick shims were installed in the gap between the CB halves. See attached photo.

Some rust near the heads of the old CB bolts

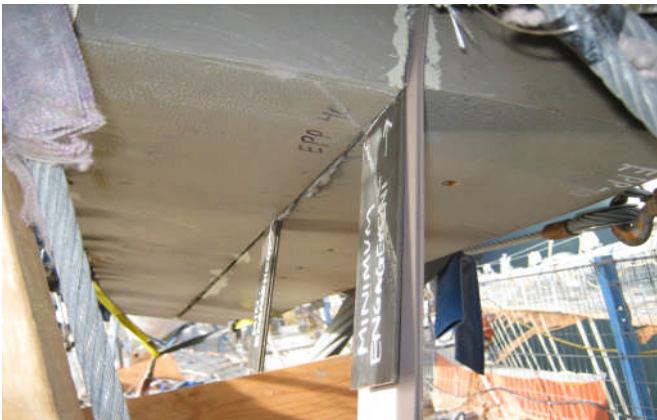
6mm thick shims installed in gap between CB halves to control the amount of gap
